National Transportation Safety Board

Marine Accident Brief

Allision of Barge *Gayle Force*, Under Tow by Tugboat *Simone*, with Norfolk Southern Bridge #7

Accident no.	DCA15LM021
Vessel names	<i>Gayle Force</i> , <i>Simone</i>
Accident type	Allision
Location	Chesapeake, Virginia, 36°46.5' N, 076°17.7' W
Date	April 26, 2015
Time	0720 eastern daylight time (coordinated universal time – 4 hours)
Injuries	None
Damage	Estimated \$1.8 million damage to the bridge
Environmental damage	None
Weather	Overcast, visibility 6 miles*, winds 5 knots from the north, air temperature 50°F
Waterway information	Southern Branch of the Elizabeth River, calm with 0.5 knot ebb current

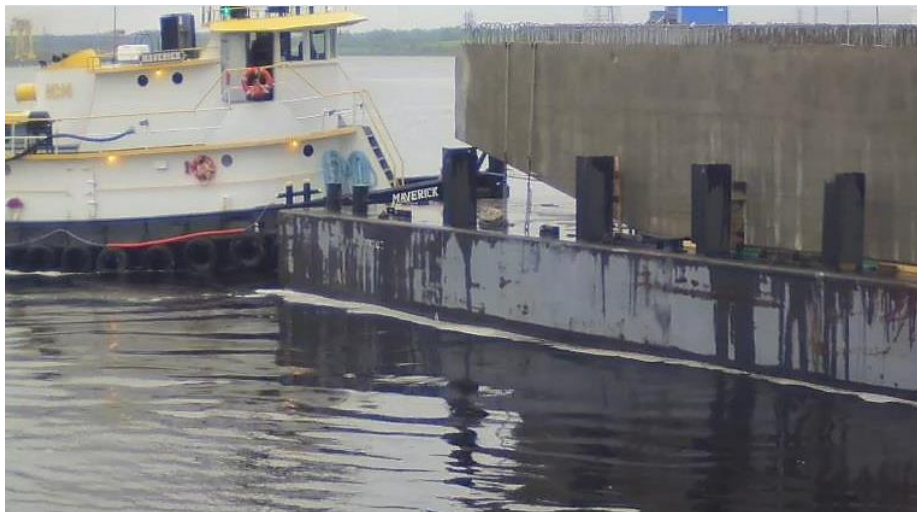
Starboard quarter of *Gayle Force* with pre-cast cement structures on deck and tugboat *Maverick* in background. (Video frame capture courtesy of Norfolk Southern Corporation)

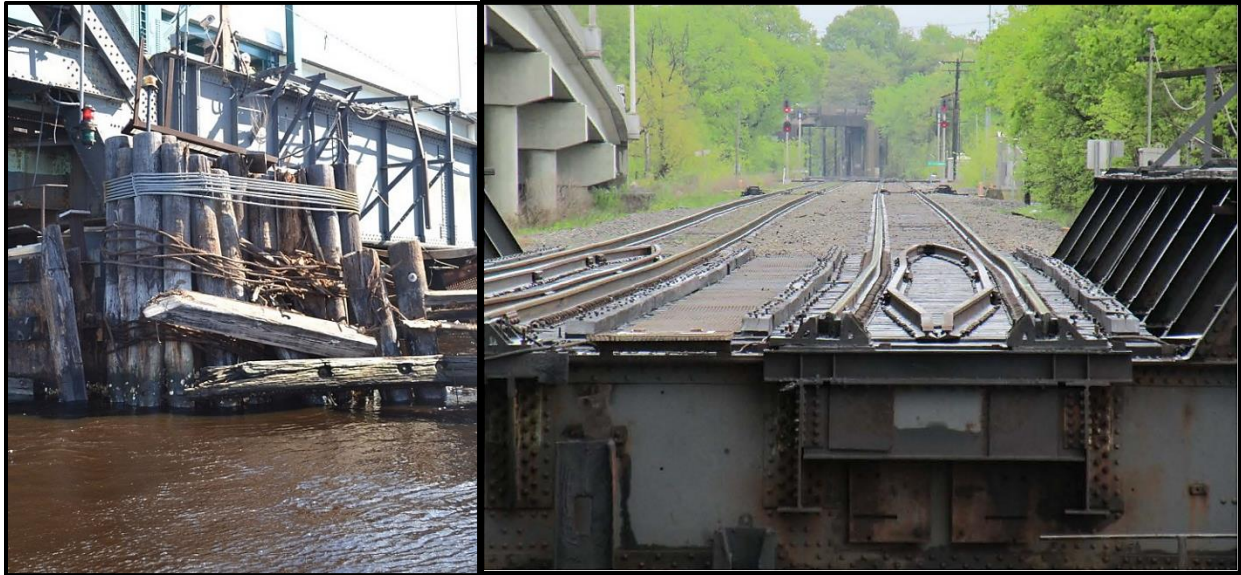
At 0720, the starboard bow of the *Gayle Force* struck the southeast fendering dolphin and concrete piers supporting the NS#7 bridge span. According to automatic identification system (AIS) data, the barge was making a speed of 4.4 knots when it struck the bridge. The timber dolphin was crushed and deformed, and the piers shifted laterally 15 inches toward the north. The rail alignment between the lift span and stationary track was misaligned by 11 inches, shutting down railroad traffic for 36 hours.

Photo left shows damage to NS#7's timber fendering dolphin. Photo right shows misaligned rails caused by the shifting of concrete piers.

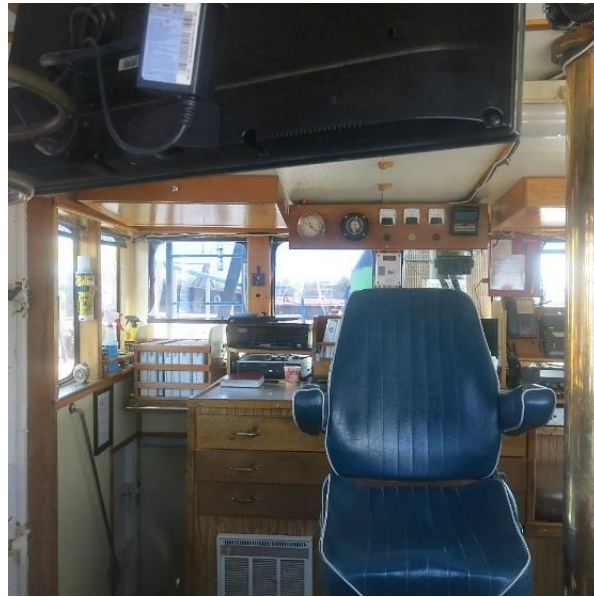
The *Simone* captain did not plan for the bridge transit in accordance with his company's policies and procedures. He did not have a clear view astern, so he relied on the mate to assist him in properly aligning the tow for the passage. But he gave no instruction to the mate. The tugboat *Maverick* was provided to assist the tow for the bridge transits of the Elizabeth River, yet the captain of *Simone* did not use the assist tugboat or ask for the *Maverick* captain's advice despite the latter's extensive experience in these waters. The *Maverick* captain was not given any directions, and the assist tugboat was placed in a location where his view was obstructed.

View from *Simone*'s starboard conning station looking aft through wheelhouse windows.
